Subject: Monthly Progress Report No. 7

CH2M HILL/E&E Oversight of Remedial Action Activities Enviro-Chem (ECC) Superfund Site, Zionsville, Indiana WA No. 008-RXBF-0530, Contract No. 68-W6-0025

ECC RA Oversight Progress Report No. 7 (July 1998)

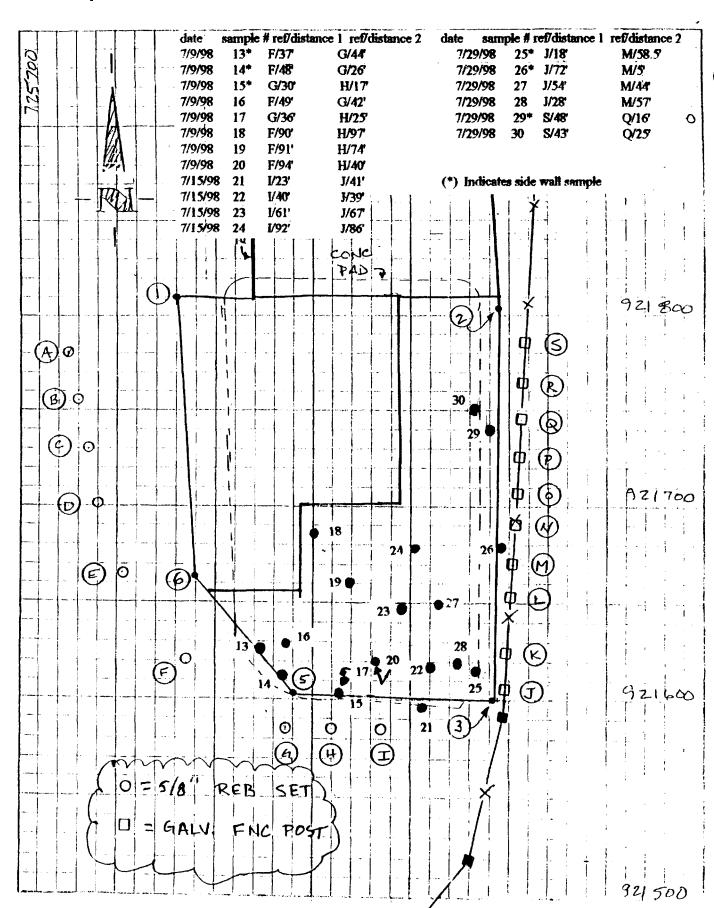
PROJECT NAME: ENVIRO CHEM @ NSL	PROJECT NO: .	799.003	SHEET Z OF Z
PROJECT PHASE	DESIGNED BY:	N.CRIBUN	DATE:
DESCRIPTION REF PTS FOR SAMPLING	CHECKED BY:	B. HULL	DATE: 13 JULI 98
			ASSUMPTIONS / REFERENCES
